SAFE USE OF SIDE-BY-SIDE OR MULTI-UTILITY VEHICLES

WorkSafe Tasmania is currently investigating an incident involving the roll-over of a side-by-side vehicle (SSV; also known as a multi-utility vehicle/MUV).

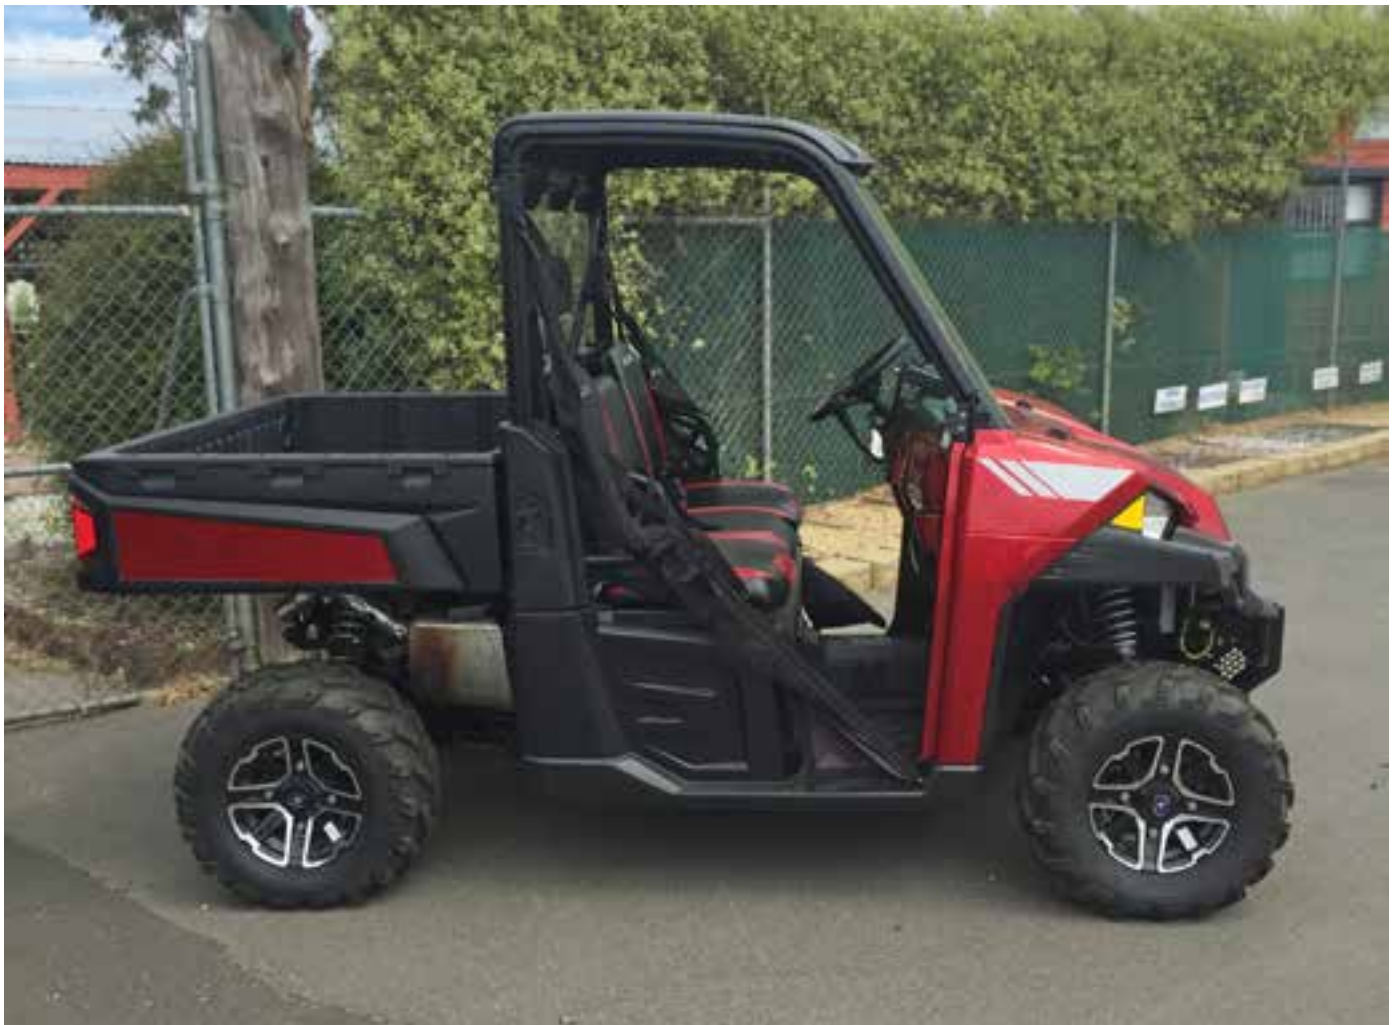
The worker was using the SSV to move livestock. He suffered serious leg and arm injuries.

- The operator was using the vehicle without proper instruction and training.
- The operator had not reviewed the owner's manual and all warning and instruction labels.
- The cab nets or doors were not in place.

- all operators review and understand the owner's manual and warning and instruction labels
- cab nets or doors are in place on the vehicle at all times
- the vehicle is operated according to the manufacturer's instructions
- operators wear seatbelts at all times
- passengers are not carried unless the operator has more than 2 hours of driving experience
- all operators are provided with adequate instruction and training that is relevant to the hazards and risk associated with using the vehicle. This should be:
 - provided by a registered training organisation (RTO), such as 'Operate side-by-side utility vehicles' AHCMOM211A (see below), or
 - a comprehensive on-the-job training program that includes assessing the operator's competency.
